WRONG DIRECTIONS: A RECIPE FOR FAILURE

Safety Alert 1 of 2

Alert 10(b)-10

SIMPLE FAILURES RENDER CO2 SYSTEM INOPERATIVE

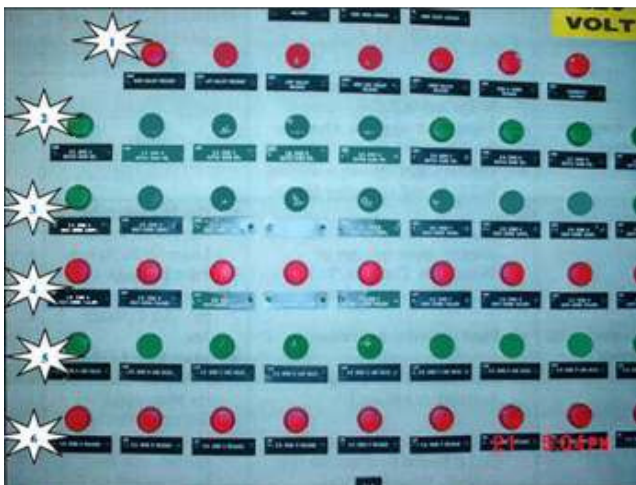
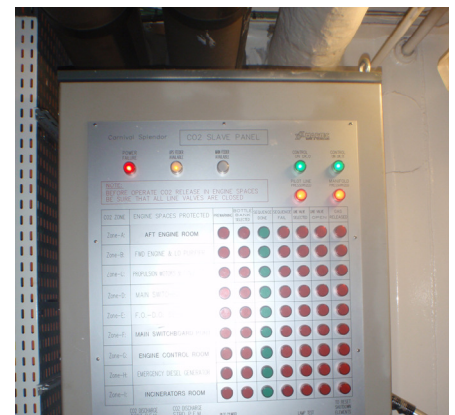
- Shipyard commissioning test procedures appear to differ from procedures documented in the vessel's Firefighting Instruction Manual (FIM). Commissioning procedures indicate that the discharge line selection to a specific protected zone should be made prior to releasing the gas contrary to the directions in the FIM.
- The FIM refers extensively to a Control Panel (left following image) that differs vastly from the one onboard the vessel (right following image).

- Ensure that all supporting documentation, piping schematics, plans, manuals, component labeling and instructions are consistent with each other and relevant to the systems, equipment, and components installed onboard the vessel.

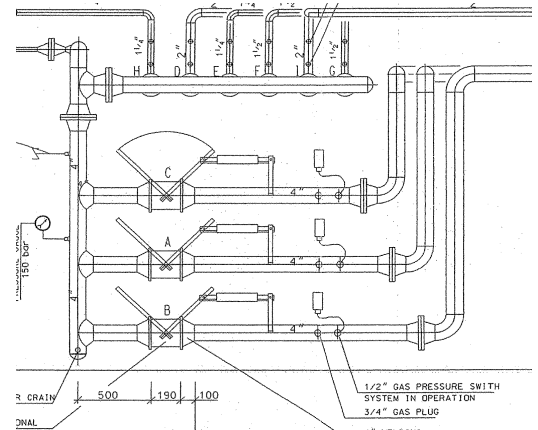
- Shipyard piping schematics and drawings do not appear to match the actual installation. The schematic at the right shows the “A valve” for the Aft Machinery Space in the center position vice the bottom position as it is installed on the vessel.

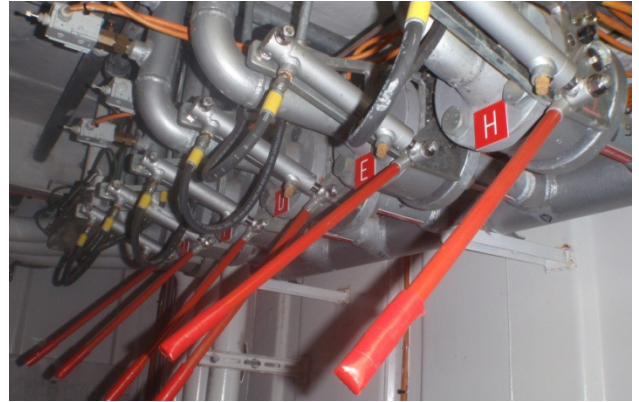
- Actuating arms to five of the six other zone valves were found loose. They were also attached by small machine screws. (Photograph at right.)

- Carefully and critically review, routinely inspect and maintain, verify and test their Fixed Fire Fighting installations to ensure that they will operate correctly during an emergency.

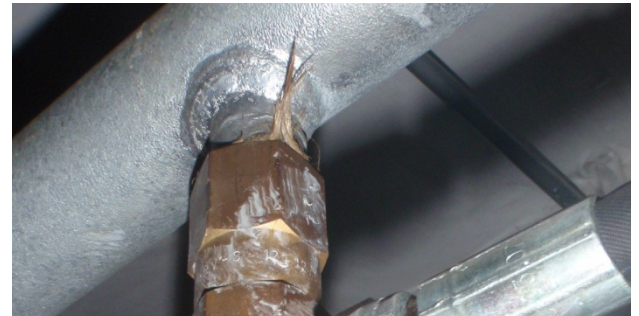
- Hemp type pipe sealant was used extensively on pipe threads throughout the system and in some instances seems to have entered the system. (Photograph at right.)

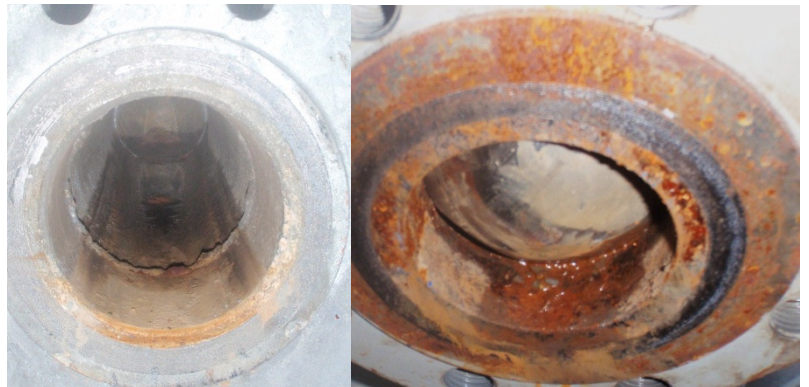
- Certain elements of the distribution manifold contained low points which allowed the accumulation of water within piping that could not be drained. Such a circumstance could cause corrosion that could possibly negatively effect operation of other components. (Photographs at right.)
