MARINE SAFETY ALERT

April 28, 2010
Washington, DC

Alert 04-10

Watertight Doors – Close Them and Dog Them!

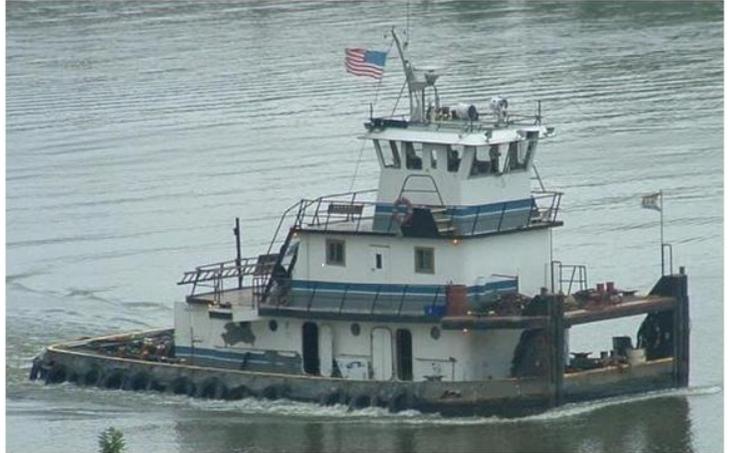
Recently a push boat operating “unfaced” (no barges attached) in the Houston Ship Channel flooded and sank while in the wake of tractor tug resulting in the death of the push boat crew and the narrow escape of two others. Although the investigation is not yet complete, it appears that the following occurred: The vessel’s watertight doors leading to its engine room had each been pinned open. The push boat had very little freeboard and was fully loaded with fuel and water. As it took the wake of the tractor tug, the vessel listed to one side and down flooded the engine room through a watertight door. As it rolled to the other side, it took on more water, eventually sink stern first

Not Actual Vessel

CLOSE THEM and DOG THEM!
