UNITED STATES COAST GUARD

MARINE SAFETY ALERT

Alert 04-11

High Velocity Vent Valves, Vacuum Valves, P/V Valves

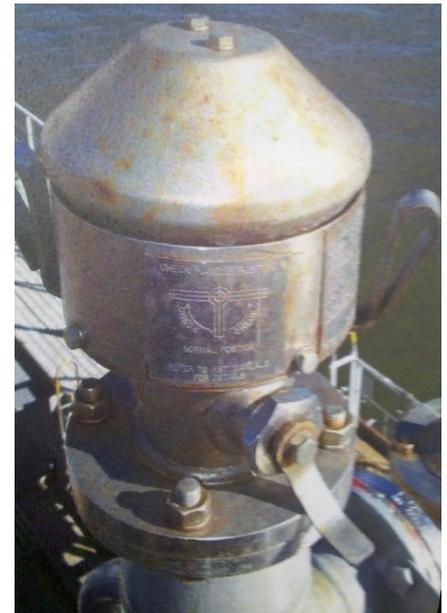
The high velocity vent valve is part of the pressure / vacuum protection piping of the cargo tank. It prevents damage to cargo tanks by normally staying closed and only opening at a preset positive pressure. Large shipboard tanks can be easily damaged by relatively low pressures. Use of these valves minimizes such occurrences. Other benefits of the valve being in a closed position is that breathing of the tank is minimized thus preventing unwanted cargo vapor releases into the atmosphere, protecting the environment and limiting the loss of cargo due to vaporization. The valves are also equipped with flame screens to prevent explosions due to ignition. The vacuum breaker component of pressure / vacuum protection piping of the cargo tank similarly protects the tank by preventing excessive vacuum from being formed.

After this specific casualty, the high velocity vent valve of the tank being filled was found stuck closed and inoperable using the manual test lever. A valve for another tank was also found stuck. Scientific testing of the substance between the stuck valve disc and the seating surfaces indicated the presence of oxidized vegetable oil or fat likely from previous cargoes. It appears doubtful that crewmembers exercised the valves prior to their cargo operations as per their operating procedure.

As a result of this casualty and others involving similar circumstances, the Coast Guard **strongly recommends** to vessel Owner / Operators, Crewmembers, Classification Society Inspectors, Vetting, and other inspection personal ensure that tank high velocity vent valves and vacuum valves, or combination pressure / vacuum valves are maintained in operating conditions at all times and are routinely checked as procedures require.
